61662 NEWS UPDATE N0. 31 & 32 (July/August 2014)

61662 PROGRESS Continued

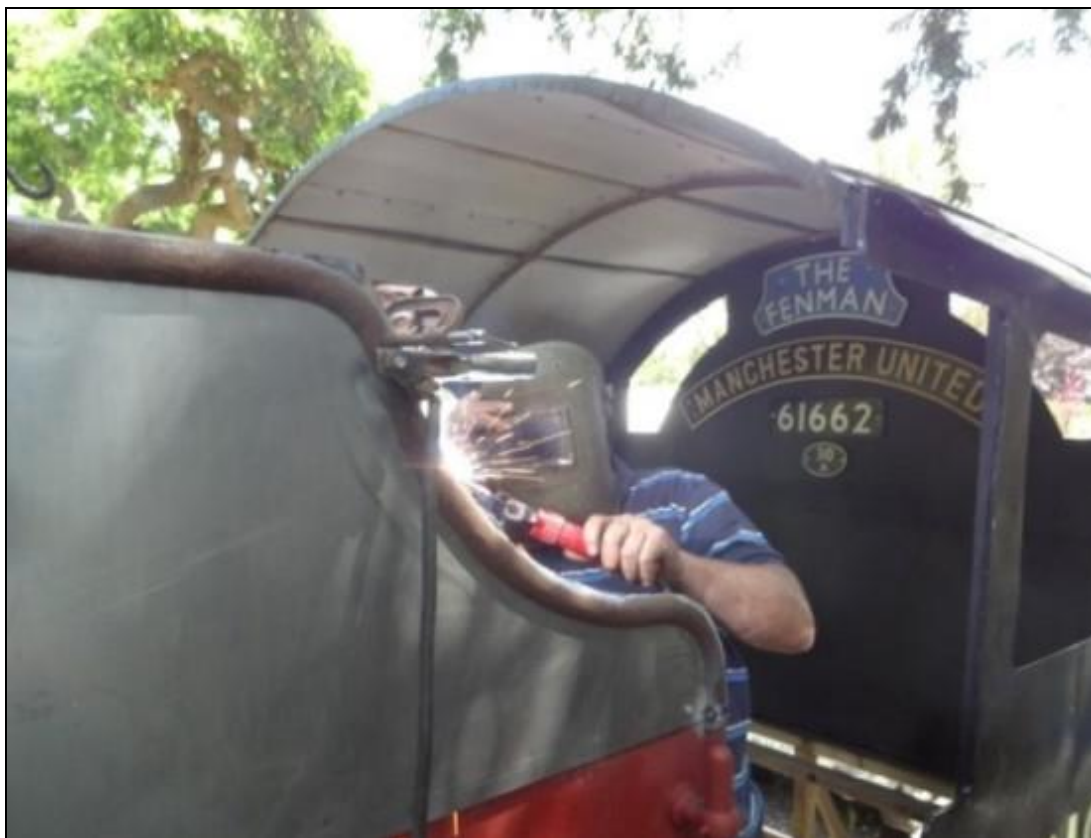
Good progress has been made repairing the right hand side coping plates on No.61662's tender this month with most of the welding and riveting completed and a coat of red oxide primer now applied. Ian Rough is seen above welding the beading back into place on the front plate with the first few rivets already fitted.

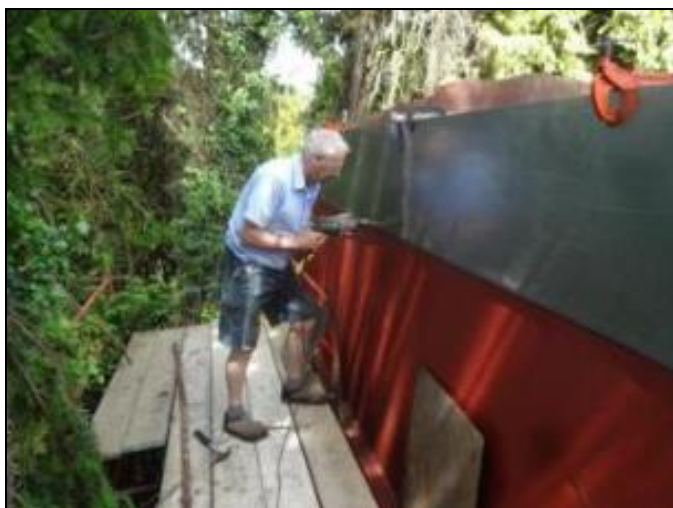
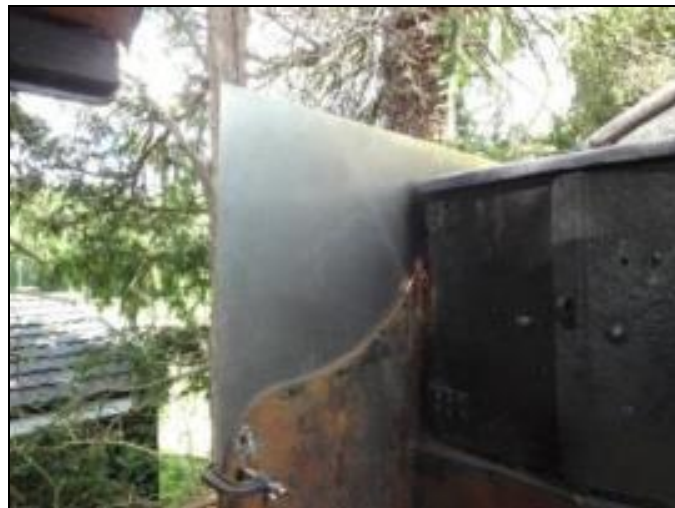
With the second and third plates securely clamped into place I was able to start drilling out holes for the rest of the new rivets. One of the long sections of beading removed from the old coping plates can be seen on the scaffolding planks behind me. This was cleaned up and straightened out ready for re-use. The third photo on this page, taken from inside the cab, shows the front coping plate temporarily bolted to the side of the tender, ready for cutting and profiling.

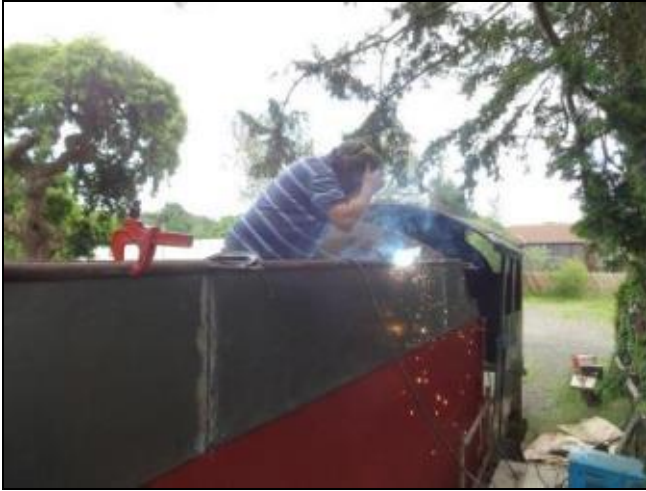
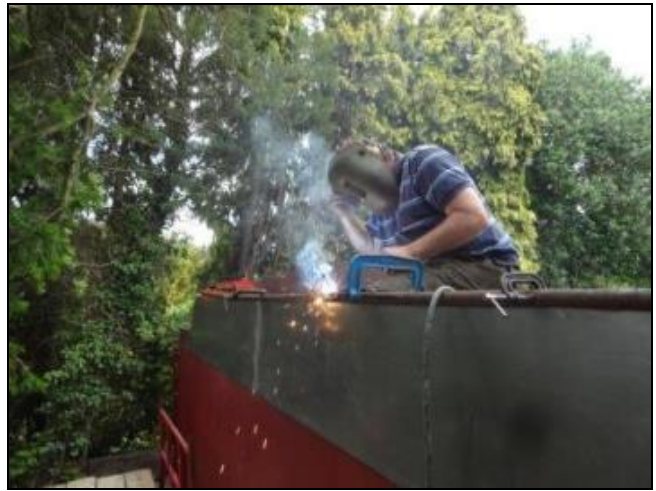
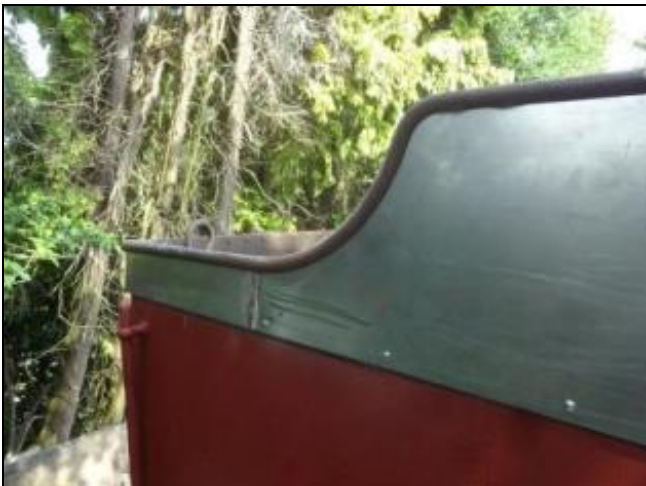
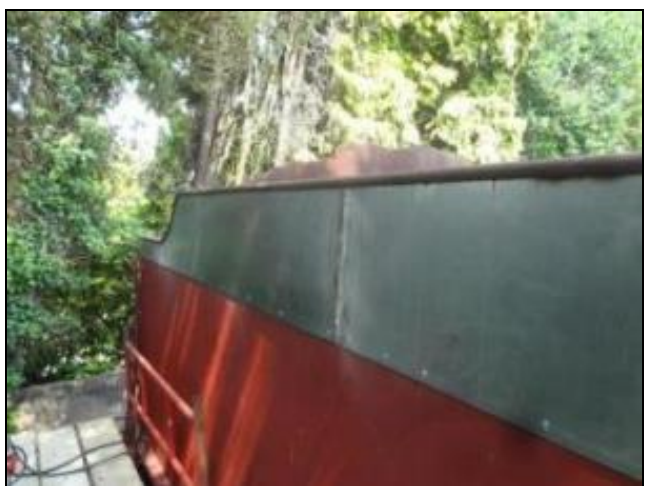
The following week, work continued on welding the beading back into place and riveting the coping plates to the tender side sheets and by the middle of June the right hand side was looking much more respectable. Around half the rivets had been fitted and it was decided that we should take some time out at this point to get some red oxide primer onto the bare metal. We'd been very lucky with the weather in mid-June but heavy rain had been forecast – luckily the paint had a full day and night to dry before the deluge started !

We've been asked a couple of times about our decision to rivet the coping plates to the side sheets rather than weld them flush and this was only done after careful consideration.

There were several different types of tenders fitted to the LNER 'Footballers'. Nos. 2862-2872 were originally of all-welded construction and the coping plates were integral with the tender sides. However, Nos. 2848-2861 had an earlier pattern with the coping plates riveted to the outside of the tender side sheets. This can easily be seen in photographs. The tenders were swapped around on a fairly regular basis and we have photos of 'Manchester United' running with a riveted tender. We therefore decided that the most cost effective way to repair our tender in the short term was to rivet the new coping plates to the side sheets. This will prevent further deterioration and make the tender much more presentable to our visitors.

The right hand side has now been repaired using this method and the left hand side has been patched up internally. It will be fitted with riveted coping plates to match the right hand side as time and money allows and both sides will receive a coat of Brunswick Green.

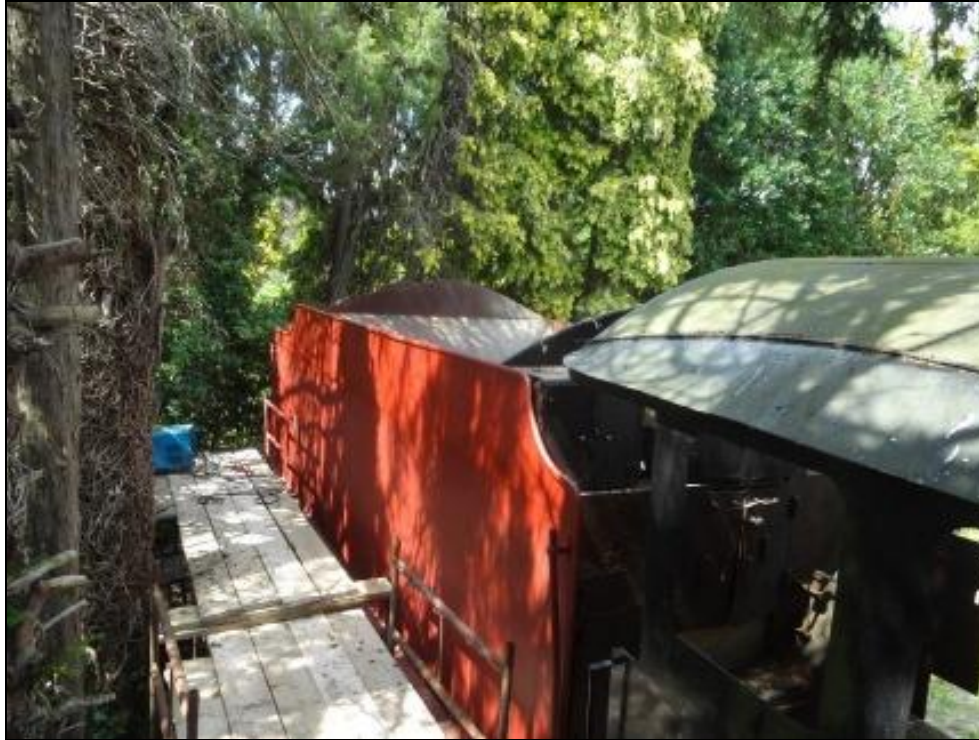
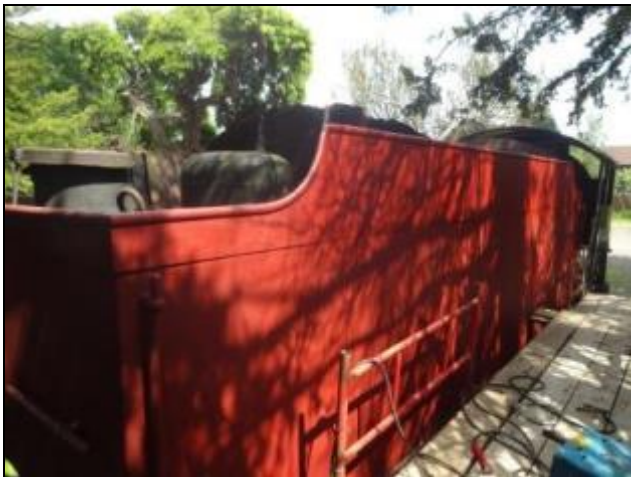
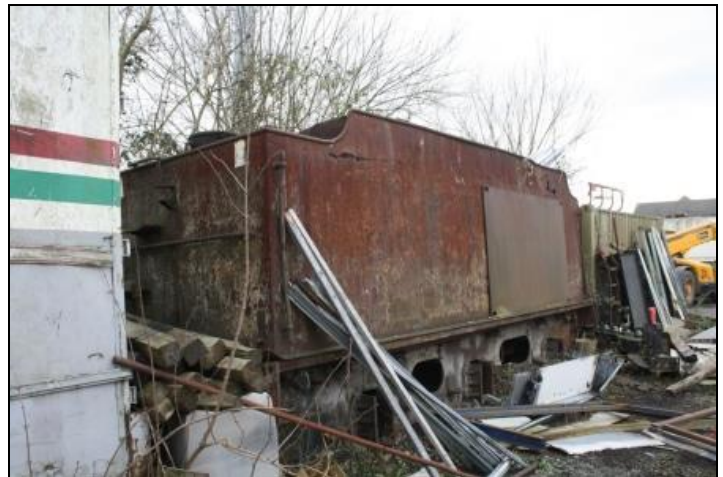
Recent pruning of the trees adjacent to our work area at the Mizens Railway has enabled us show some new views of No. 61662's tender and cab as they now look today. By way of comparison, I've included a photo of the tender as was before we rescued it from the scrapyard last year, in rusty condition without wheels.
